HAWK MOUNTAIN DAM

NDI ID No. PA-01129
DER ID No. 54-180

PHASE I INSPECTION REPORT

⑥ NATIONAL DAM INSPECTION PROGRAM.

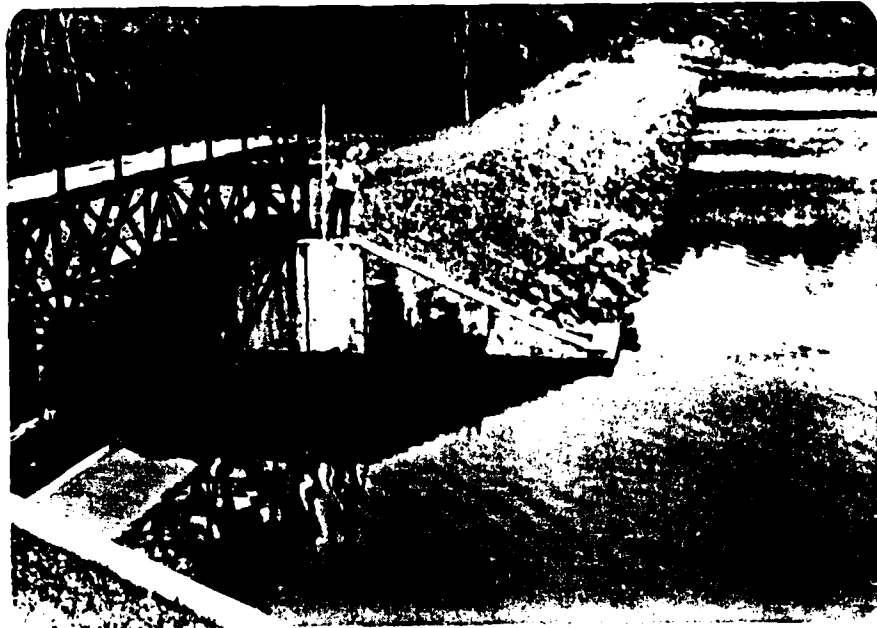
b. Embankment. The embankment is in generally good condition. The only deficiency is the very poor growth of grass on the upper parts of the upstream and downstream slopes (Photographs A and B). Because the slopes are virtually unprotected, rainfall and surface runoff have eroded several very shallow swales in the nearly bare soil. Some of the soil has migrated onto the drain material on the downstream slope. A few very shallow swales have also been eroded into the drain material. The Owner reported that he has reseeded the embankment several times, but that grass has never grown well on the dam. At present he is restricting access, to avoid unnecessary foot traffic causing problems on the unprotected slopes.

A. Upstream Slope

(1) As is presently being attempted, establish an adequate grass cover on the embankment.

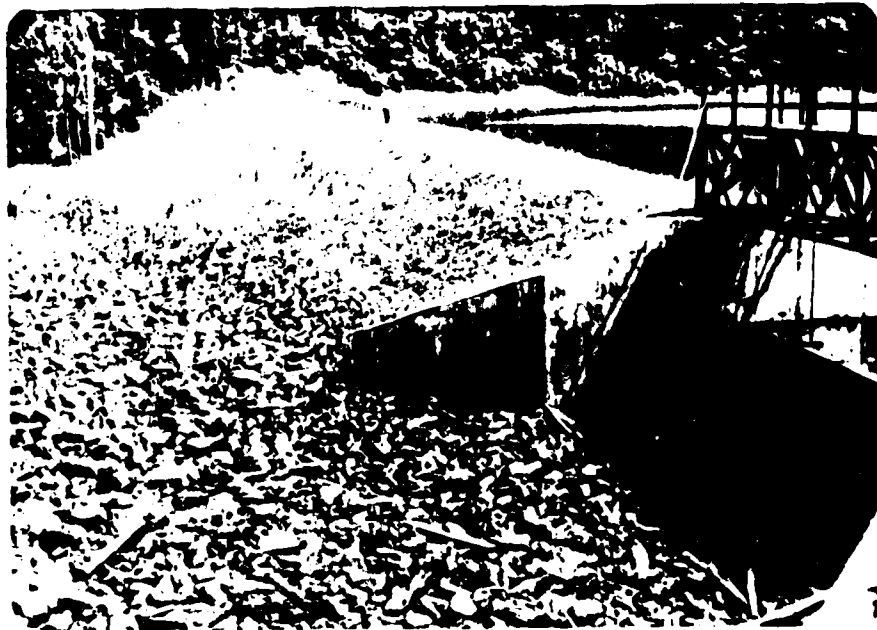
B. Downstream Slope

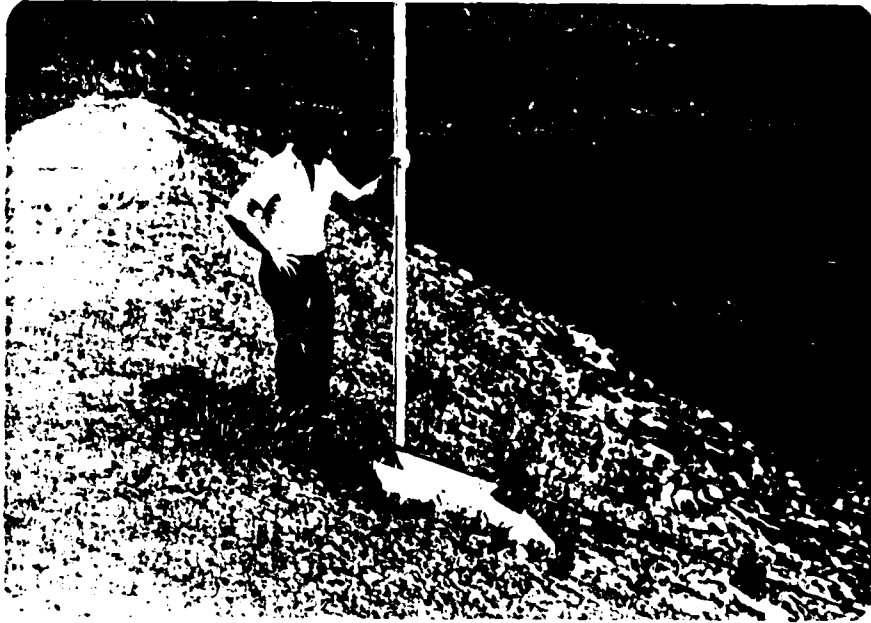
c. Appurtenant Structures. The outlet works is in good condition (Photographs C and D). The Owner opened the outlet works gate about 5 percent without any problems. The main spillway is in good condition

C. Outlet Works Operating Mechanism

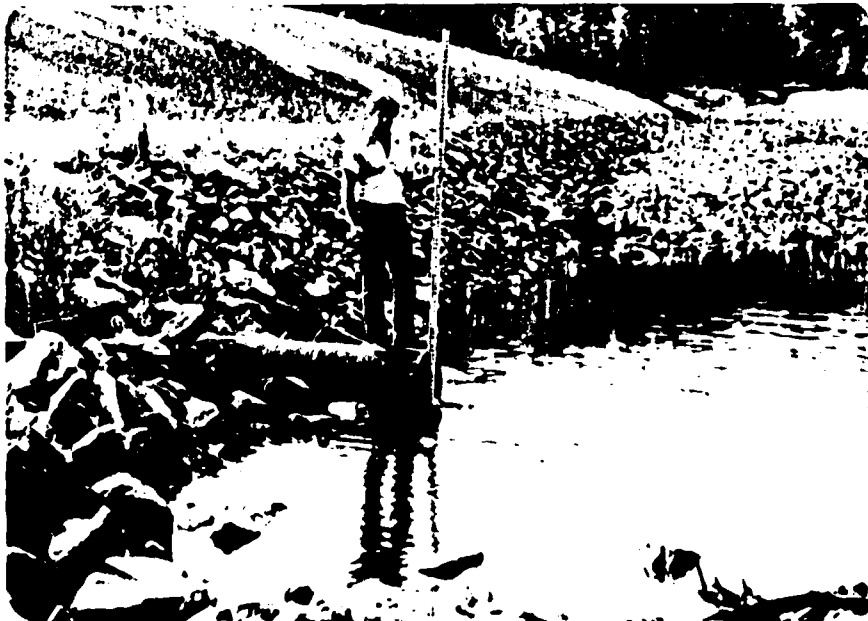
D. Outlet Works Outfall

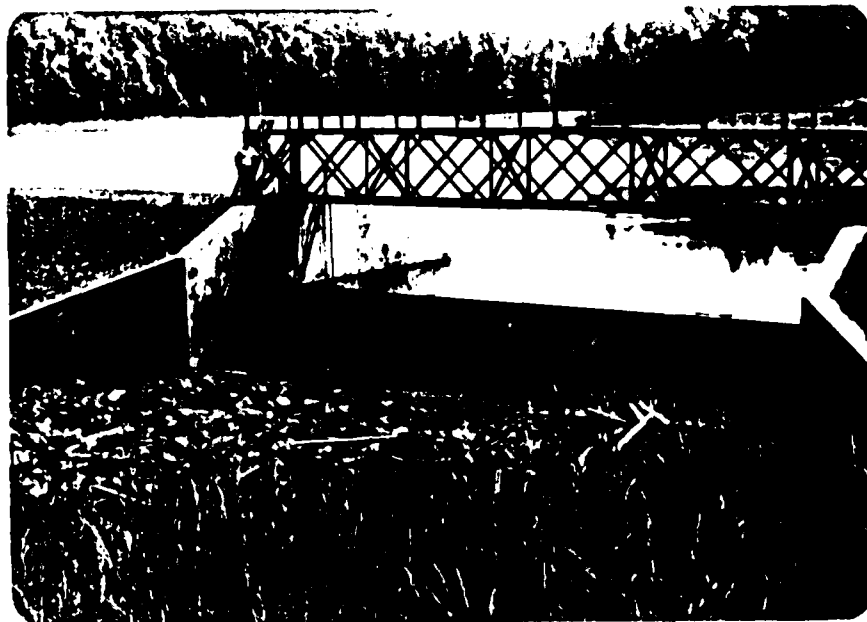
(Photographs A and E). The only deficiency observed at the area was significant seepage of about 2 gpm from one weephole at the left downstream wingwall (Photograph F). The spillway bridge is also in good condition. The spillway exit channel is protected by large riprap, which is in good condition.

E. Spillway
